# **NASA Independent Review Team**

## **Orb-3 Accident Investigation Report**

### **Executive Summary**

**Date of Event: October 28, 2014**

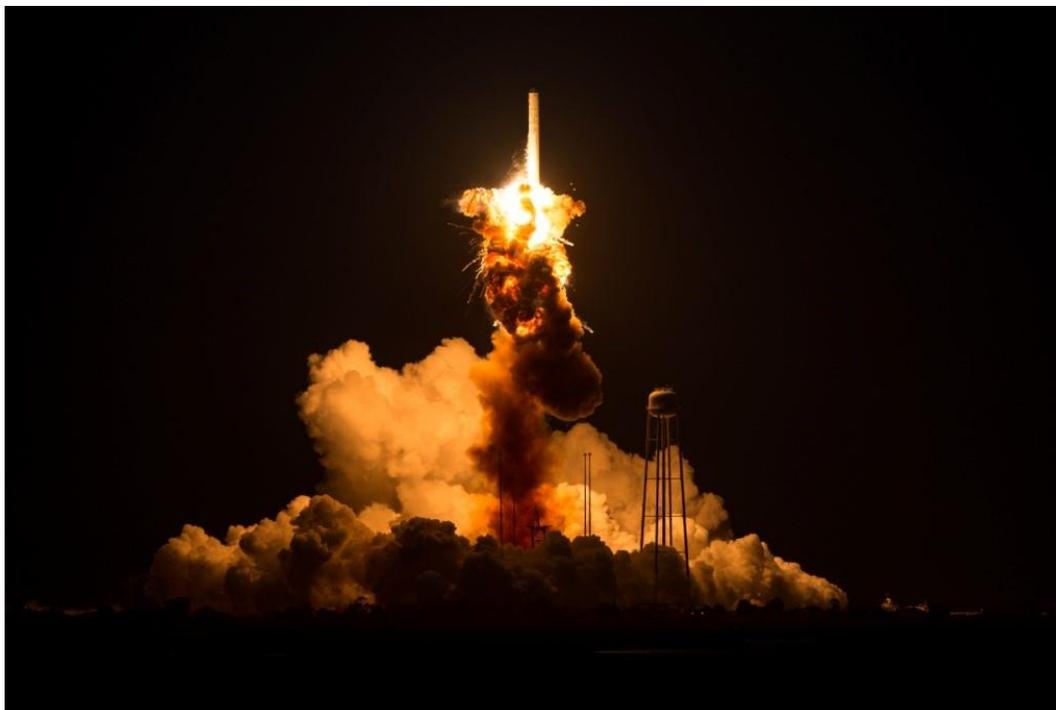
Just over 15 seconds into flight, as shown in Figure 1, an explosion in the Antares Main Engine System (MES) occurred, causing the vehicle to lose thrust and fall back toward the ground. Just prior to Antares impacting the ground, range safety personnel issued a destruct command to the Flight Termination System to minimize the potential damage from the expected ground impact and ensuing explosion of the vehicle. The launch vehicle impacted near the launch pad resulting in loss of the vehicle and cargo. Although there was damage to the launch pad and adjacent facilities and buildings, there were no injuries to members of the public or workers involved in the launch. Figure 2 shows the condition of the launch pad on the day following the accident.

Figure 1. Antares Failure during Orb-3 Launch

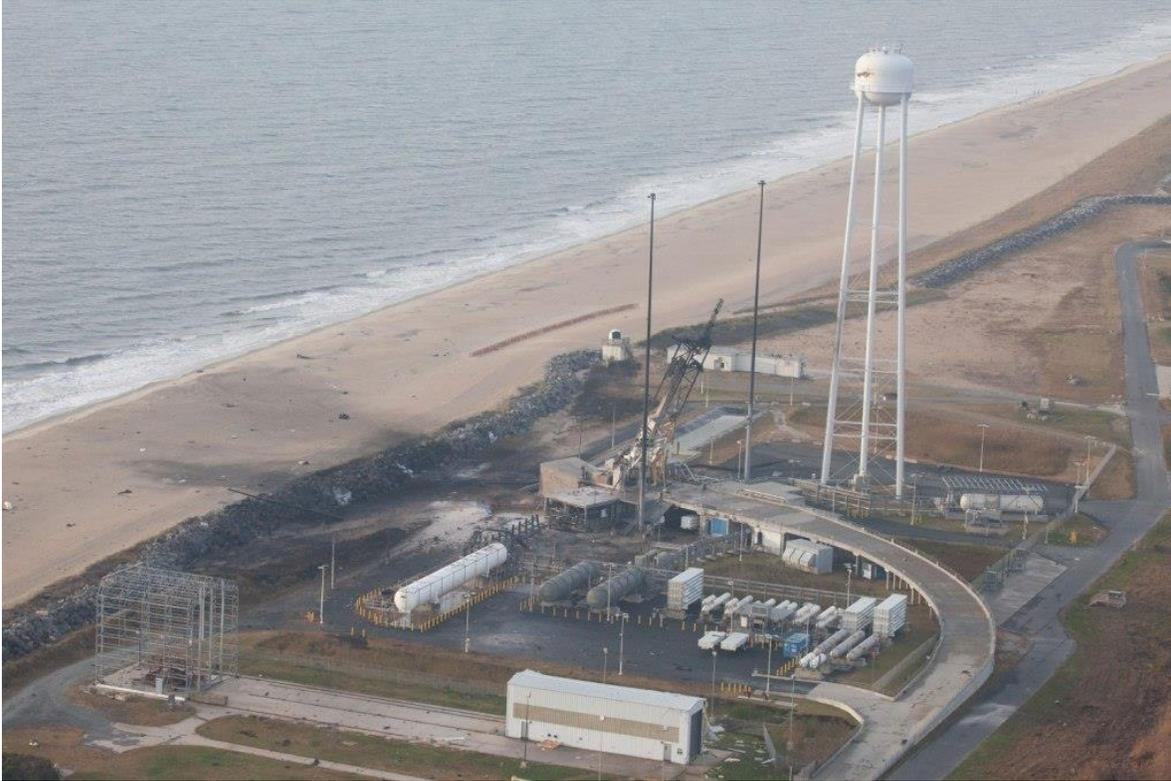
Figure 2. Antares Launch Pad Damage Following the Orb-3 Accident
